The Department of Environment Protection and Energy Maanshan Iron & Steel Co. Ltd

2022 4 A#
2#3#4#

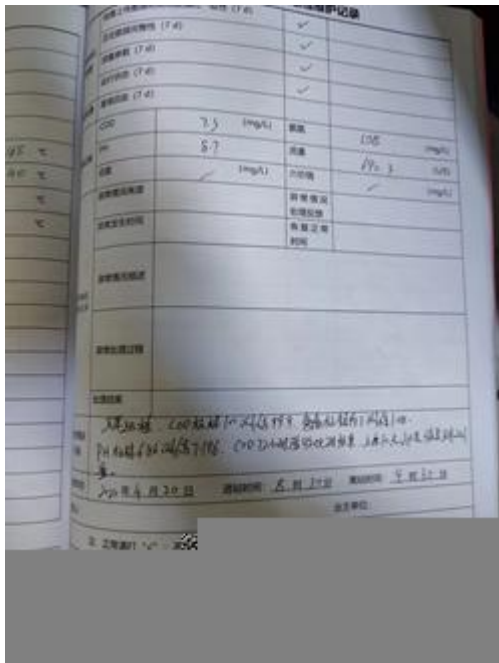
四、能控北 4#排涝泵站

2022 4 18 -4 20 4#
 (CODcr) 18 76.10 mg/L 19 142.57
 mg/L 20 71.06 mg/L COD
 72 COD

*污染源： 马鞍山钢铁股份有限公司

*标记类型： 调试

*开始时间： 2022-04-17 15:00:00

*监测因子： pH 化学需氧量 氨氮 流量

*备注： 厂家调试

*监控点： 能控北4#排涝泵站

*子类型： 自动监测设备新装调试

结束时间： 2022-04-20 17:00:59

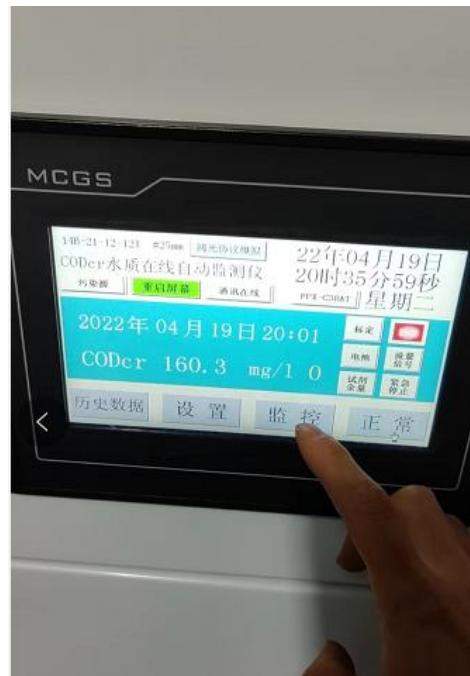
五、冷轧北水处理排口

2022 4 19 -4 20
 (CODcr) 19 70.982 mg/L 20 148.195
 mg/L COD 72
 COD
